APOLLO 9

30-DAY FAILURE AND ANOMALY LISTING REPORT

APOLLO 9
30-DAY FAILURE AND ANOMALY LISTING REPORT

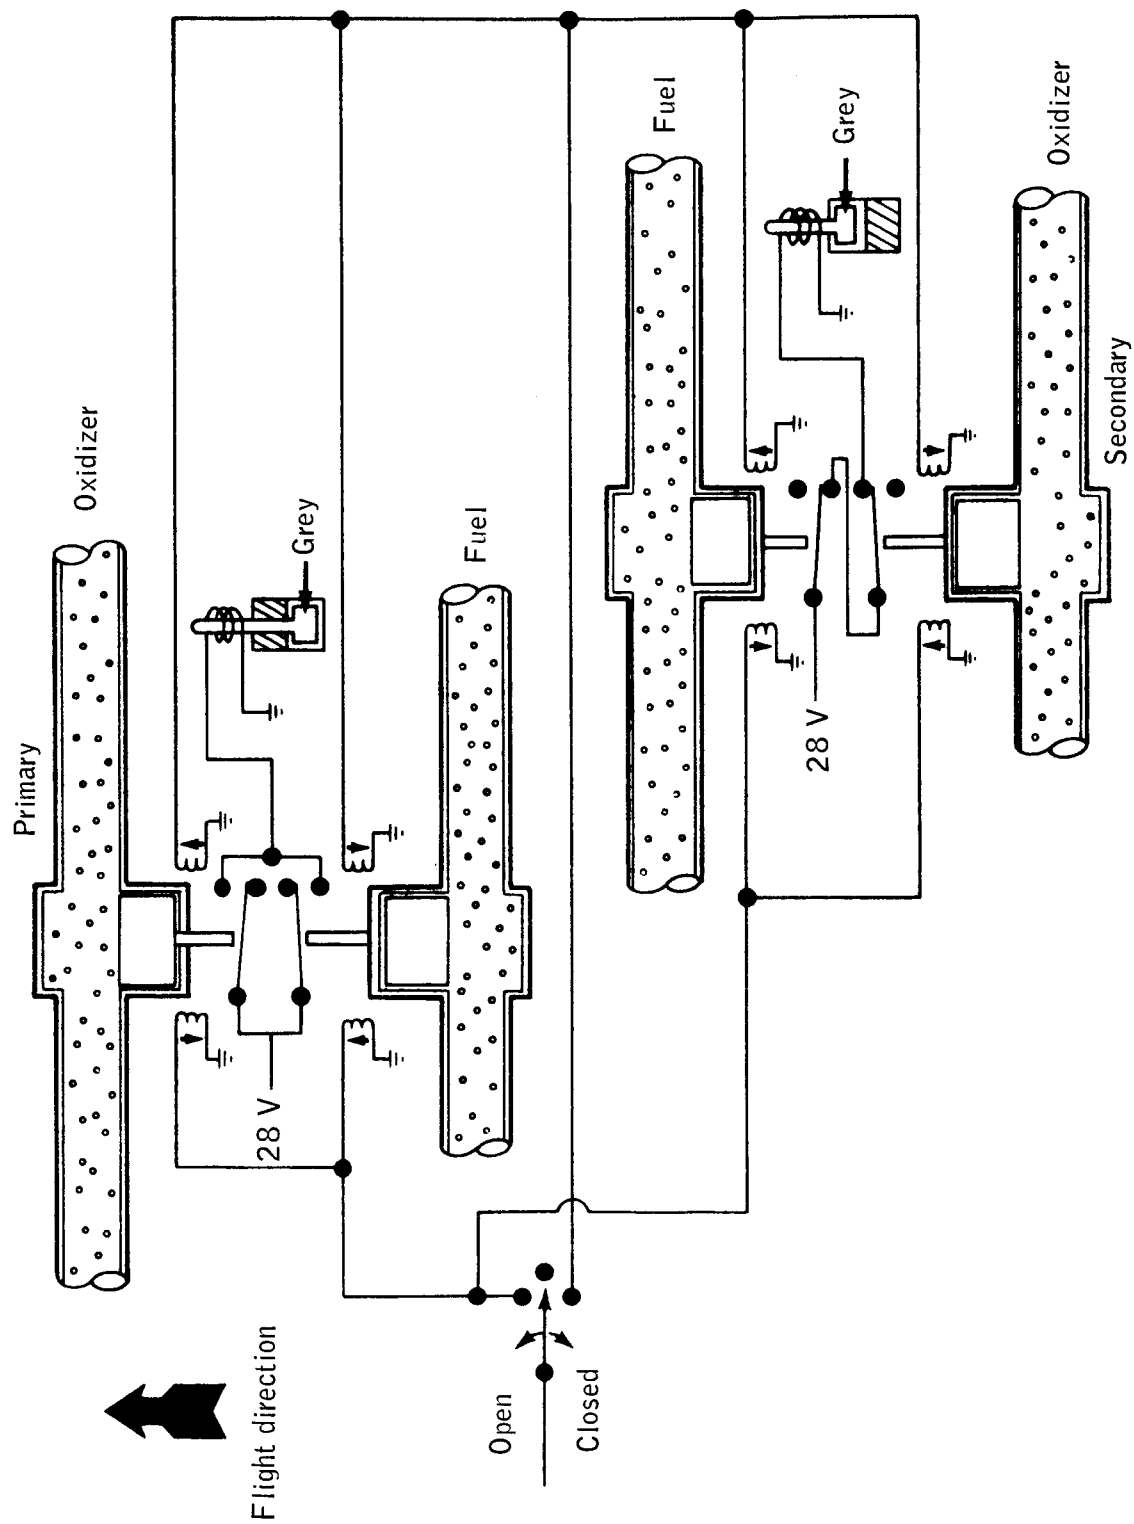
Figure 1.- Reaction control isolation valve.

Following separation from the S-IVB, the crew reported a control problem which had lasted for about 12 minutes during the transposition period. The crew first noticed a lack of capability for translation to the left. The position indicator flags for the quad C primary and secondary propellant isolation valves and the quad D secondary valves were in the "barber pole" or closed position (fig. 1). The valves were opened and the system performed normally thereafter. These valves had been opened during final checks prior to launch and were verified to be open by the crew just prior to separation from the S-IVB.

Propellant usage and quad temperature data showed that all four quad C valves were closed and that quad D was performing normally before the crew opened the propellant isolation valves. Propellant may be supplied from either the primary or secondary tanks and only the secondary tank valves were closed on quad D. Angular rate data transmitted shortly after the valves were opened verified normal operation of quad C.

5. Valve closure caused by mechanical shock at separation of the command and service modules from the adapter - Shock tests were run on a service module reaction control system valve to establish the level of shock that would be necessary to cause a normal valve to close. A cross sectional view of the valve is shown in figure 2. Results of the test indicate that a shock of about 80g could cause a valve to close. The shock resulting from the pyrotechnic charges used to separate the command and service modules from the adapter may have been between 40 and 100g (analyses to refine these values are in progress).

The most probable cause of the inadvertent closure was the shock at separation from the adapter. Apparently, the shock is of sufficient magnitude, direction, and location that it could have caused these valves to close. The particular valves that might close are a function of the normal latch force of the valves in question and the attenuation and direction of the shock from the separation at the location of the valve.

The Apollo Operations Handbook (AOH) will be changed to insure that the crew check the propellant isolation valves immediately after separation and that they reopen any valves which may have closed.

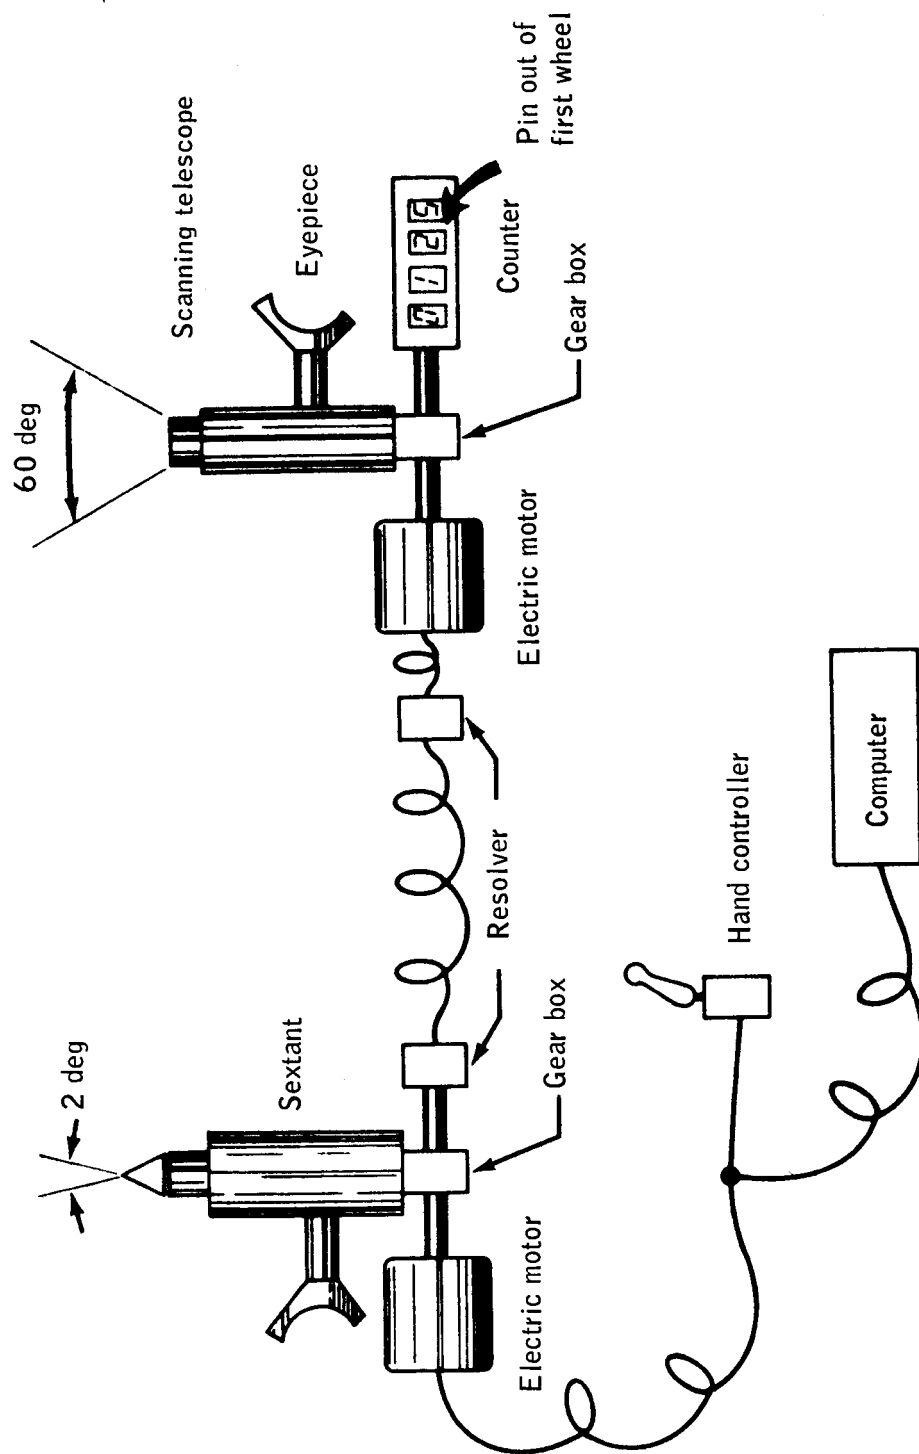
Figure 3.- Scanning telescope counter.

The "degrees" drums of the telescope shaft angle counter on the optics control panel froze at 64 degrees on the first day of the mission. The "tenths" drum continued to rotate (fig. 3). During an alignment of the inertial measurement unit on the second day, the shaft drive mechanism stopped intermittently. In some cases, the universal tool had to be used to operate the optics manual adjust screw to free the mechanism. The drive mechanism persisted in jamming intermittently until the fifth day, after which the problem disappeared.

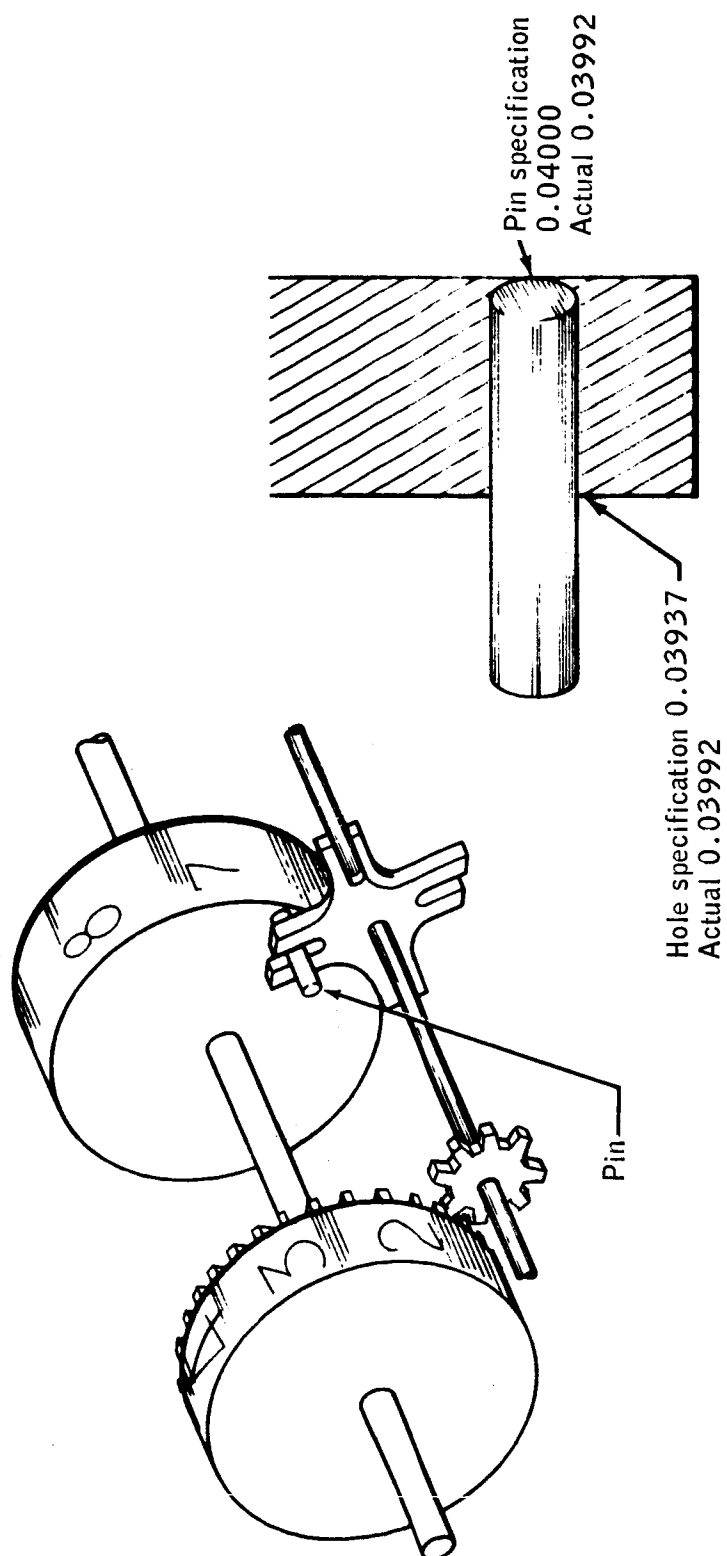
Figure 4.- Scanning telescope counter.

The optical unit assembly was removed from the spacecraft, and electrical drive tests showed that the drive mechanism was free. When the unit was disassembled, the pin from the "tenths" drum of the counter geneva mechanism drive (fig. 4) was found wedged in a split gear on the drive shaft of the one speed resolver in the telescope gear box.

The problem resulted from an out-of-tolerance condition on the hole into which the pin was press-fit. The counters for command modules 106

and subsequent and lunar modules 5 and subsequent will be replaced with units which have been specifically inspected for this condition. This anomaly is closed.

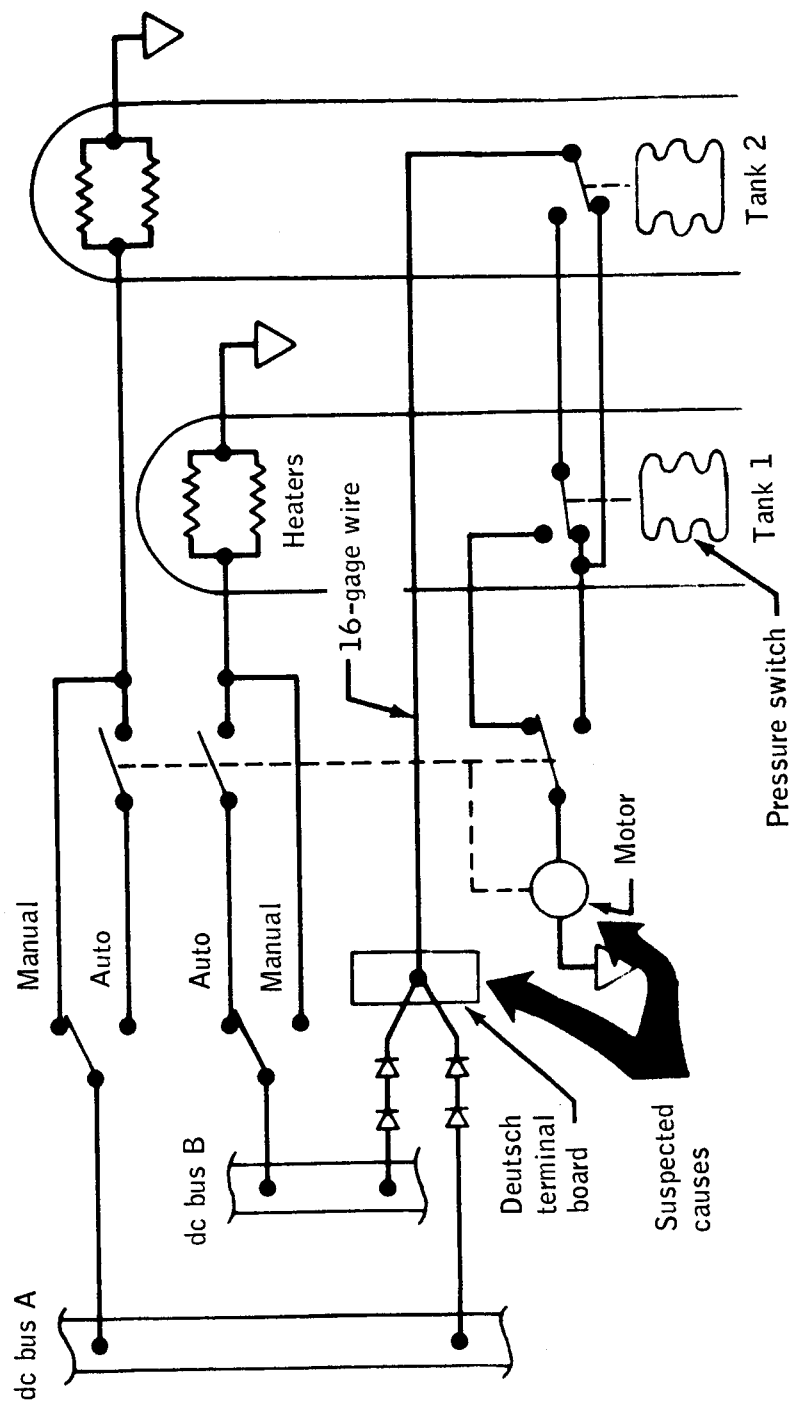
Figure 5.- Hydrogen tank pressure control.

During the flight, the automatic pressure control system in the hydrogen tanks failed. The logic of the control system (fig. 5) is such that the pressure switches in both tanks must close in order for the heaters to be activated; however, opening of only one pressure switch will deactivate the heaters. The first indication of failure was noted at 93 hours, shortly after the initial undocking, when the heaters were not automatically activated (fig. 6). At approximately the time of the final lunar module undocking, all hydrogen tank heaters came on and pressurized the tanks to about 270 psia, which required that the heaters be turned off manually.

Since the first failure (failure to turn on) would have required one pressure switch to fail open and the second failure (failure to turn off) would have required that both pressure switches fail closed, the switches can be ruled out. The most probable cause for the failures was an intermittent condition in the motor or its control circuit (including the power line, ground, and the terminal board for 16-gage pins) resulting from the undocking shock (see fig. 5). Sixteen-gage terminal boards have been the source of intermittent contact during vehicle ground tests.

No corrective action will be taken for Apollo 10; the tank pressures can be controlled manually by either the heaters or the fans if the automatic system fails.

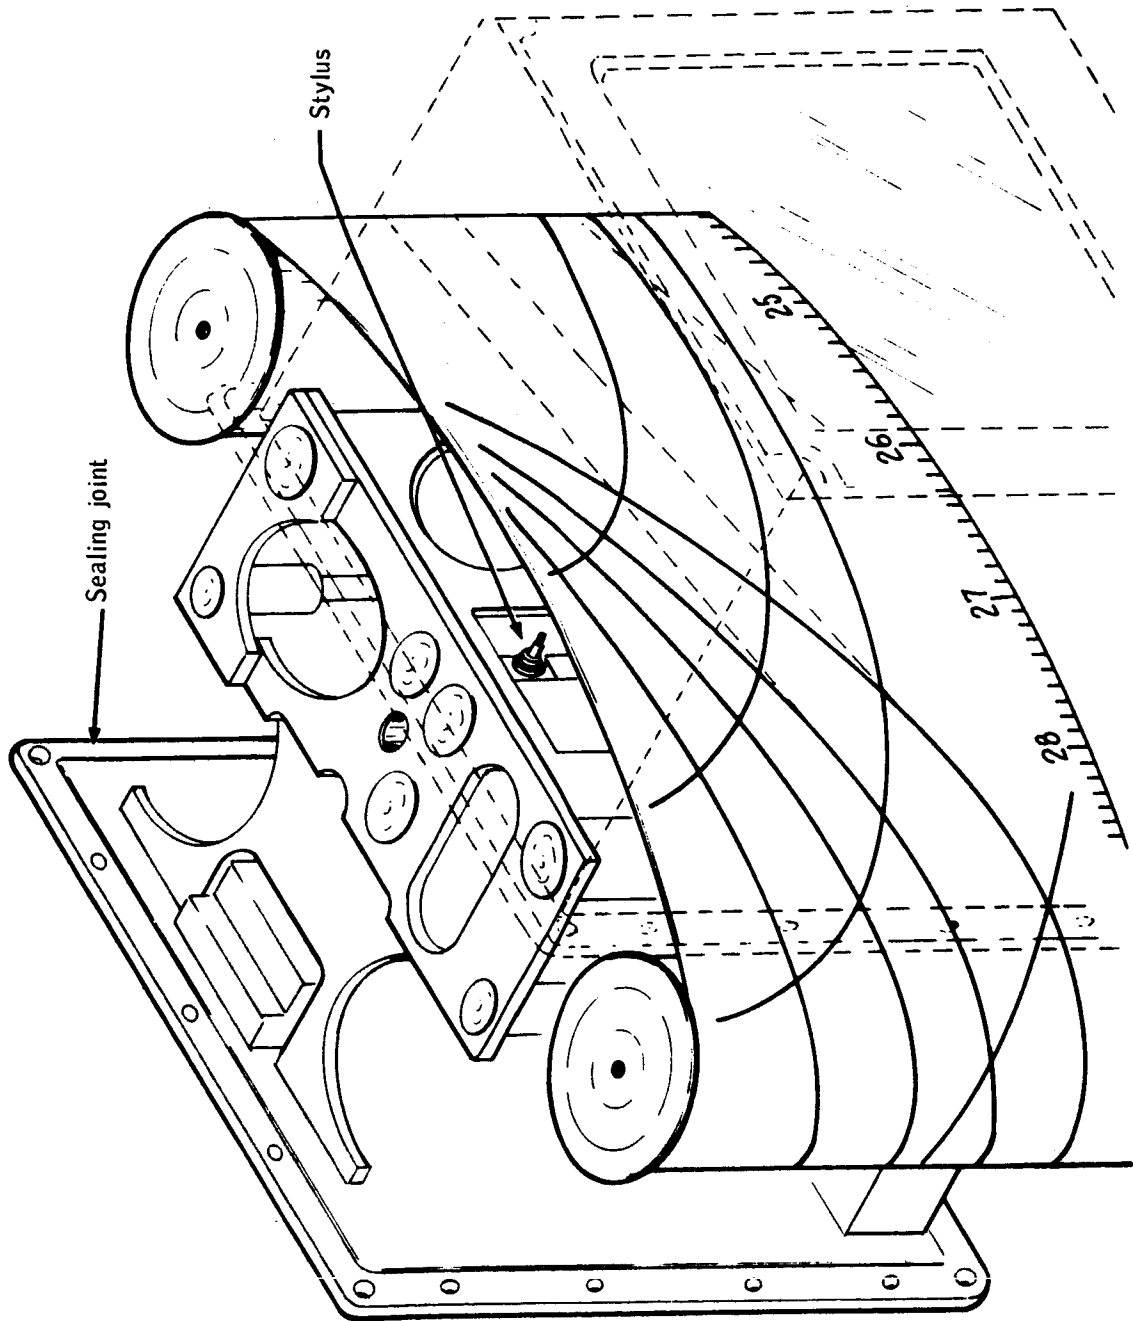
Figure 8.- Entry monitor system.

The entry monitor system stylus did not continuously cut through the emulsion on the scroll assembly. The accelerometer output of the entry monitor drives the stylus to scribe the acceleration (g) history

versus velocity. The emulsion on the Mylar scroll film is cured and kept in a dry atmosphere by enclosing the scroll assembly inside a sealed case under one atmosphere of dry neon gas to maintain the proper consistency of the emulsion (see fig. 8). The characteristics of the emulsion change if moisture is absorbed, causing the substance to harden.

A leak was found in the scroll assembly postflight; the leak would allow the case to breathe moisture inside. A leak-tested scroll assembly, with a finer stylus point which will penetrate harder emulsions, and several other minor modifications will be installed in Apollo 10.

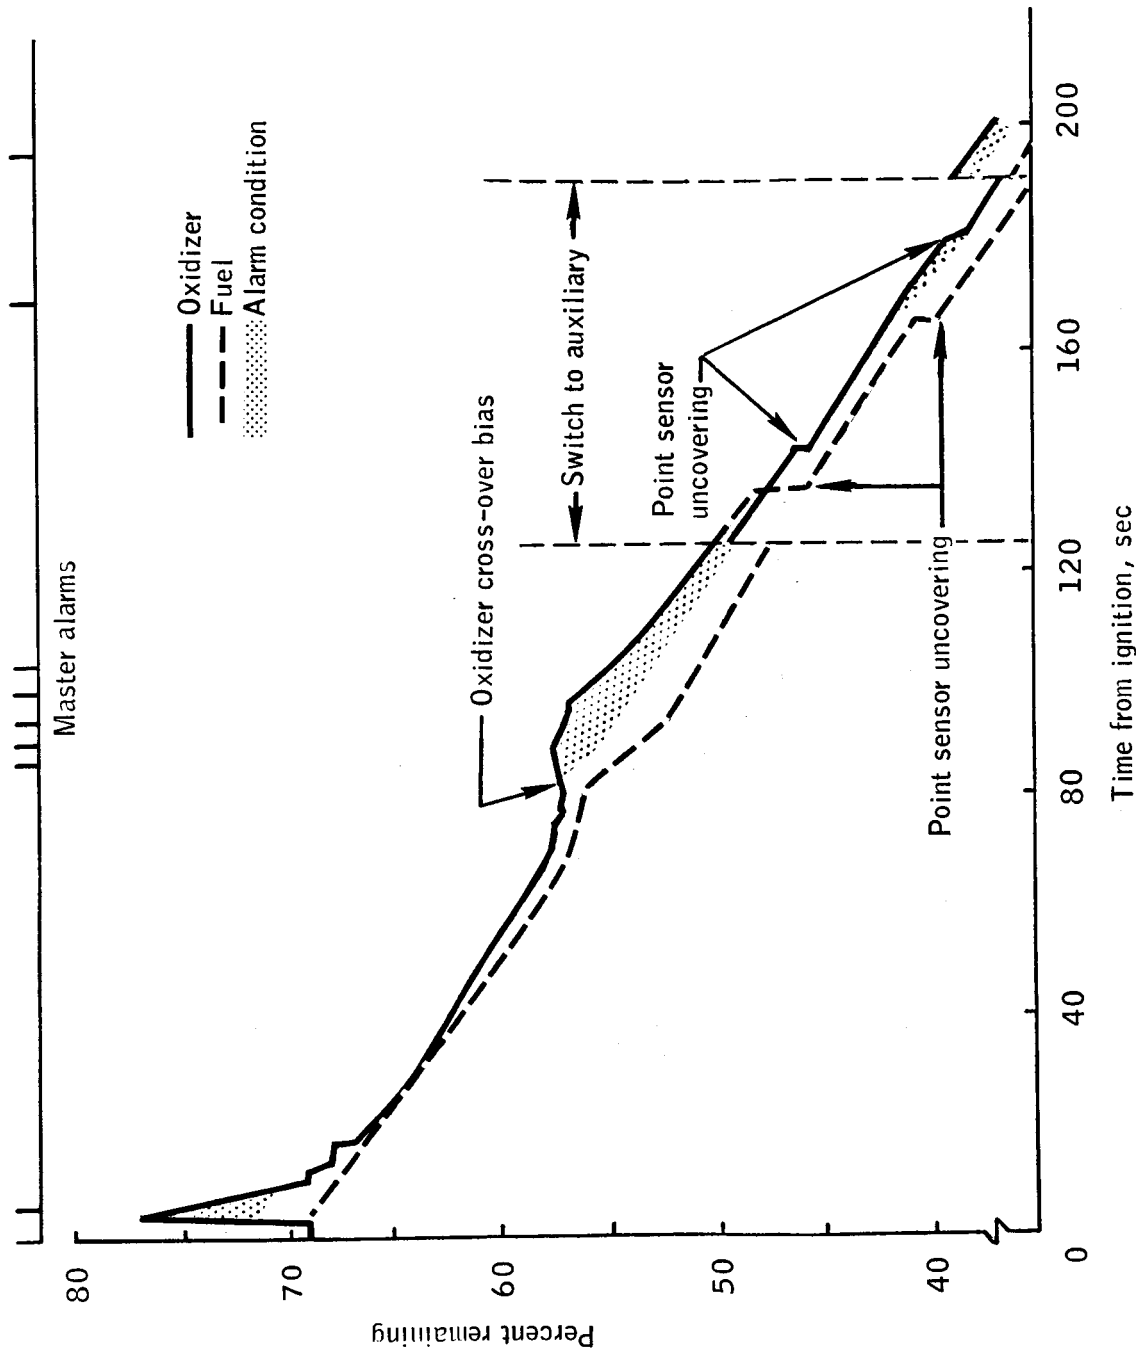
Figure 9.- Service propulsion system propellant quantities.

During the third firing of the service propulsion engine, there were eight master alarms from the propellant utilization and gaging system indicating an excessive propellant unbalance (fig. 9).

All the master alarms are explainable. The first alarm was caused by propellant level in the capacitive measuring tube not reaching the settled level soon enough after start-up. The next five alarms, shown in figure 9, resulted from an electrical zero bias in the oxidizer measuring circuit after storage tank depletion. Thus, continuous alarms on the primary gaging system caused the crew to switch to the auxiliary system, which employs point sensors at discrete levels in the tanks.

A legitimate unbalance caused an alarm during the auxiliary system operation, as noted. Also, switching back to the primary system resulted in another legitimate alarm, even though the zero bias existed.

A calibration and appropriate adjustment will be made during pre-flight servicing to compensate for the zero bias at tank crossover. Additionally, procedures have been changed for the crew to ignore the unbalance during the first 25 seconds of a firing to allow sufficient time for propellant settling.

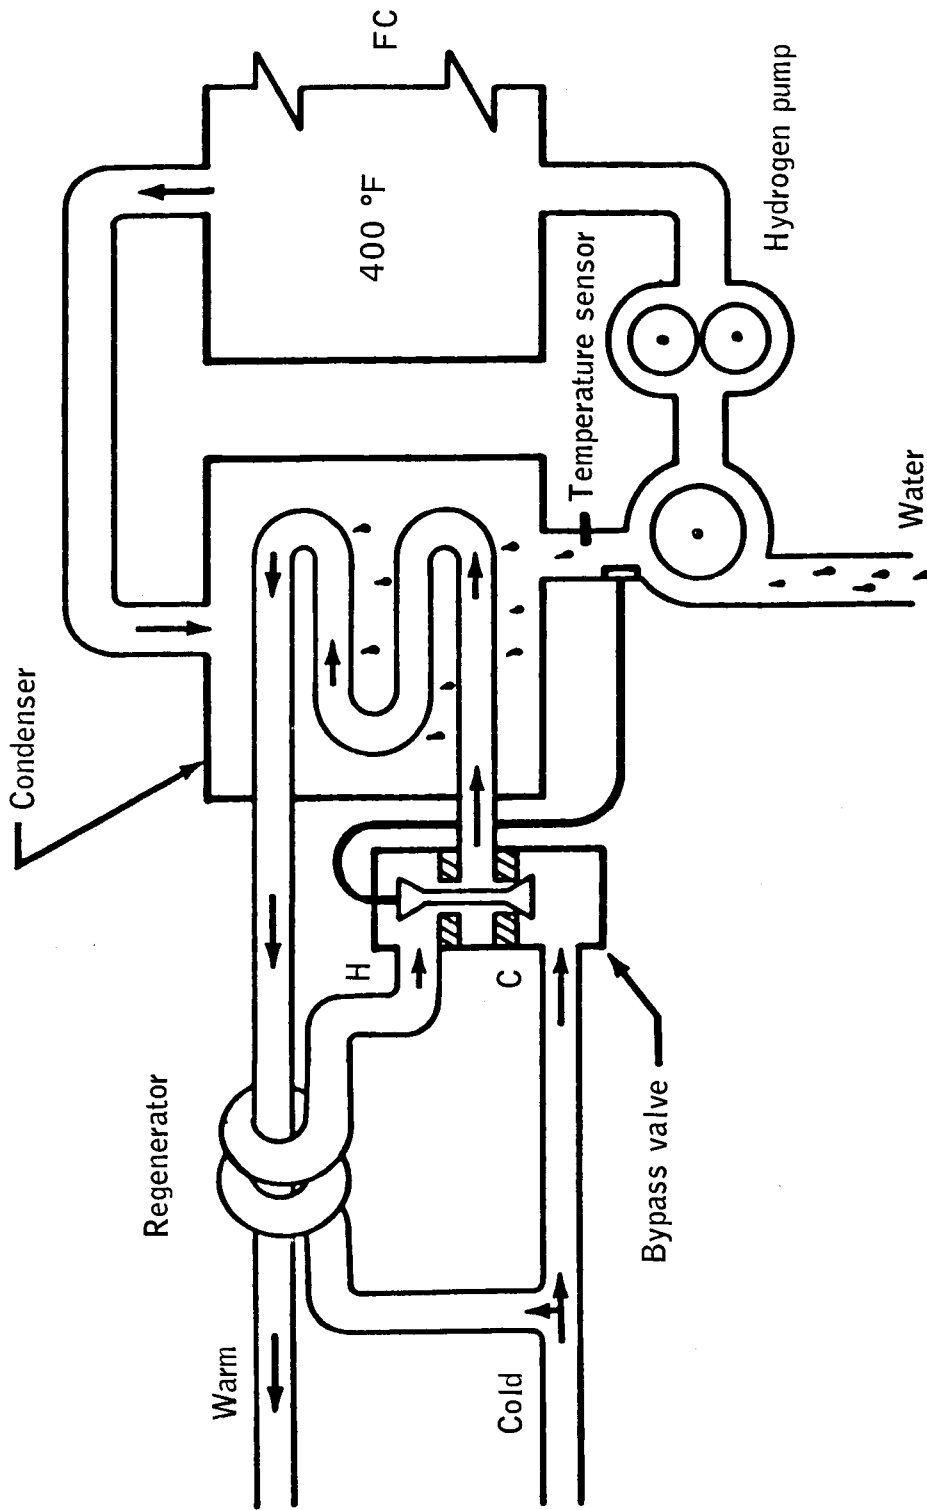
Figure 11.- Condenser system.

The condenser exit temperature for fuel cell 2 was outside the normal range (155° to 165° F) on numerous occasions. This condition was similar to that observed on Apollo 7. Analysis shows that the travel of the secondary coolant regenerator bypass valve (fig. 11) was restricted between approximately 4 and 10 percent bypass between 88 and 191 hours. The condenser exit temperature remained within normal operating limits at all loads after 191 hours. The loads after that time were relatively high, requiring normal bypass valve modulation between 8 and 19 percent.

Previous ground tests and analysis of coolant drained from vibration and flushing operations of other spacecraft show that coolant loop contamination buildup in the valve caused the restricted travel of the bypass valve. This contamination is present in the form of gelatinous phosphates and/or solid particles.

For Apollo 10, the radiators will be vibrated and a volume exchange made 30 to 45 days prior to launch (the Apollo 9 spacecraft had only a volume exchange 45 days prior to launch). An in-line change to use the

block I bypass valve, which is less susceptible to contaminants, has been made.

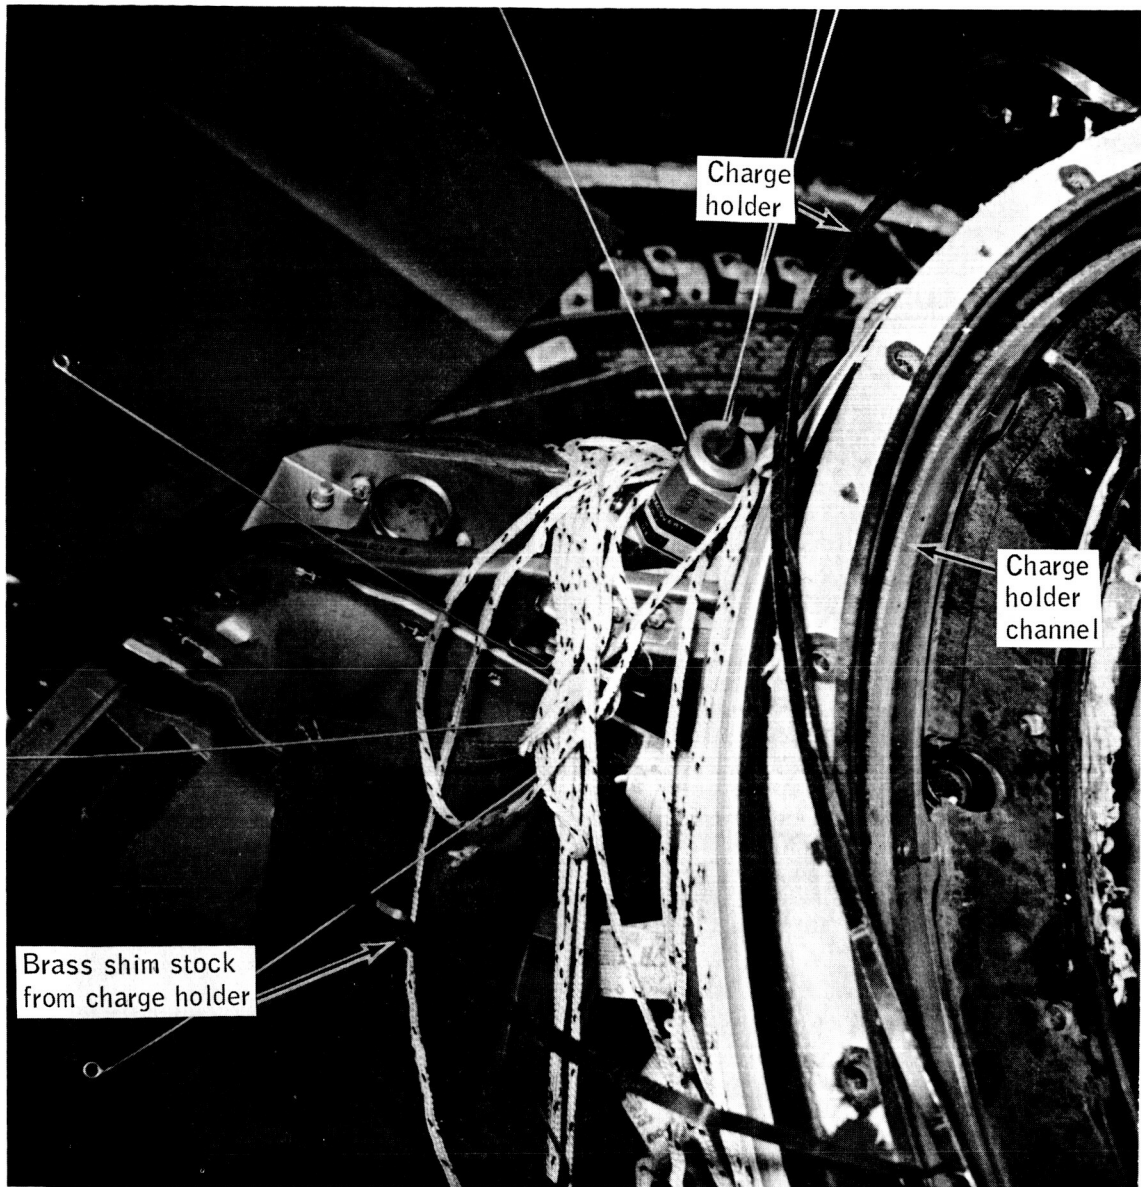
Figure 12.- Top of tunnel structure after recovery.

One docking ring separation charge holder was deformed and out of its channel, extending several inches beyond the periphery of the external tunnel structure (fig. 12). Such a configuration might foul or cut the nylon riser lines during parachute deployment.

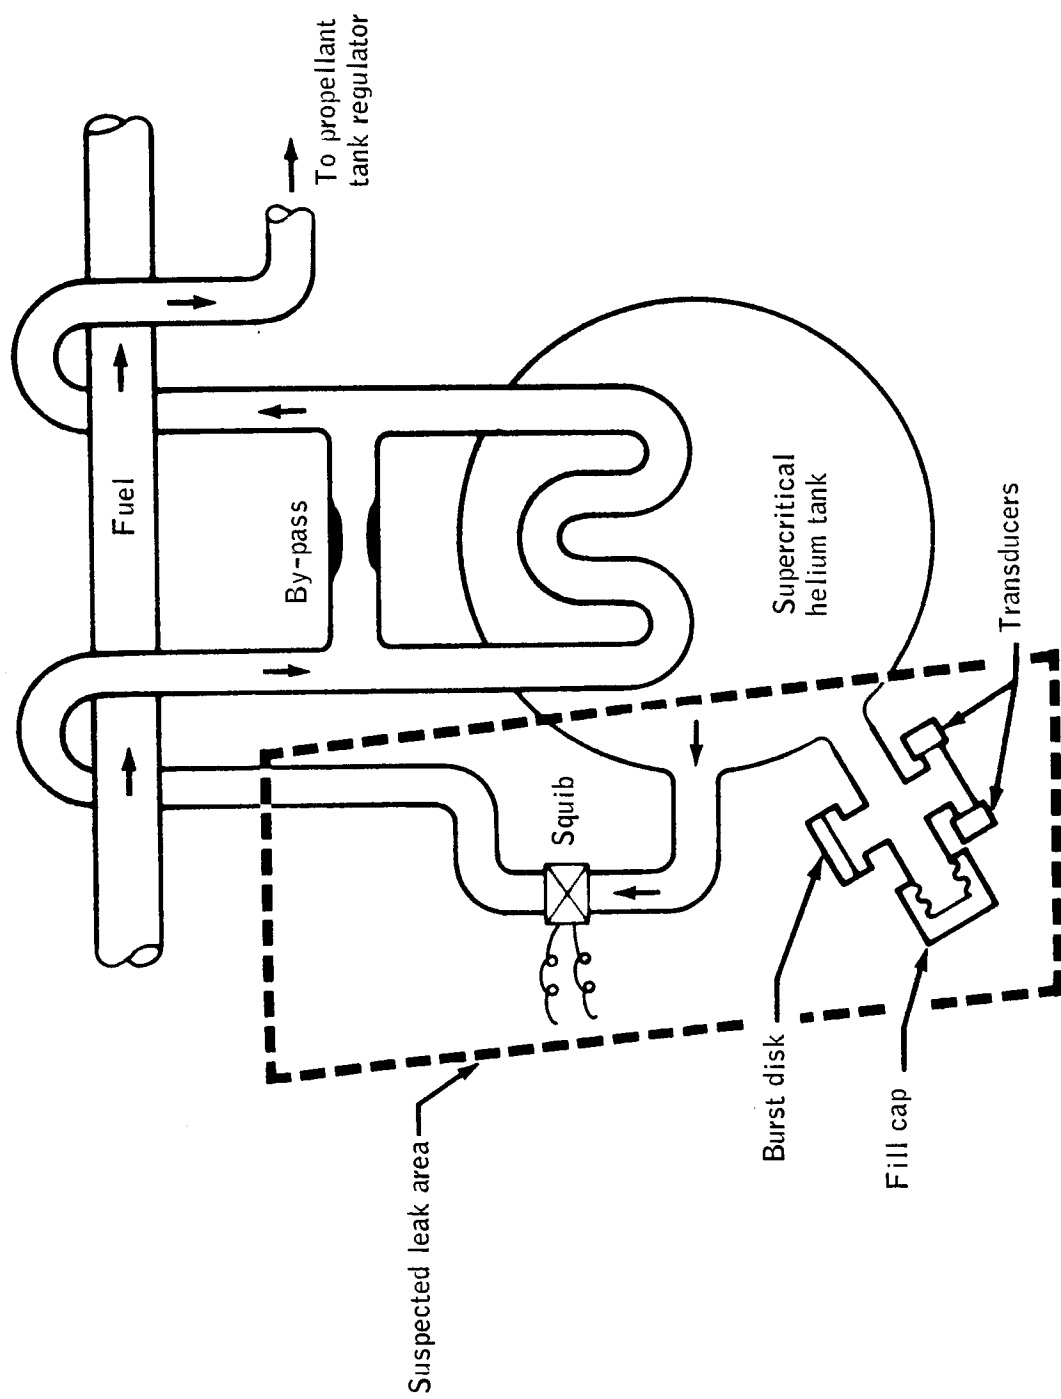
Figure 18.- Supercritical helium pressure decay.

The pressure in the supercritical helium tank for the descent propulsion system began decaying at 2.9 psi/hr immediately after shutdown of the first descent engine firing and continued to decay until staging. Because of heat transfer into the tank, the pressure should always increase under no-flow conditions (fig. 17). The pressure decay is indicative of a leak of about 0.1 lb/hr from the helium system. Analysis of the data indicate the leak was upstream of the solenoid valve and probably upstream of the supercritical helium tank heat exchanger.

The flight configuration of helium tank, squib valve, bimetallic fitting, and associated plumbing has not been tested together for response to squib valve firing shock (fig. 18) other than the LM-1 flight, which showed no sign of leakage. A test is being run on the LM-4 flight configuration to determine whether or not the components from the tank to the fuel heat exchanger have sufficient strength margin for thermal, vibration, and squib valve firing shock.

Testing on the LM-4 configuration will be completed about April 13. If a failure occurs or measured stress levels are excessive, modifications will be incorporated on a second specimen. This test should be completed about April 19.

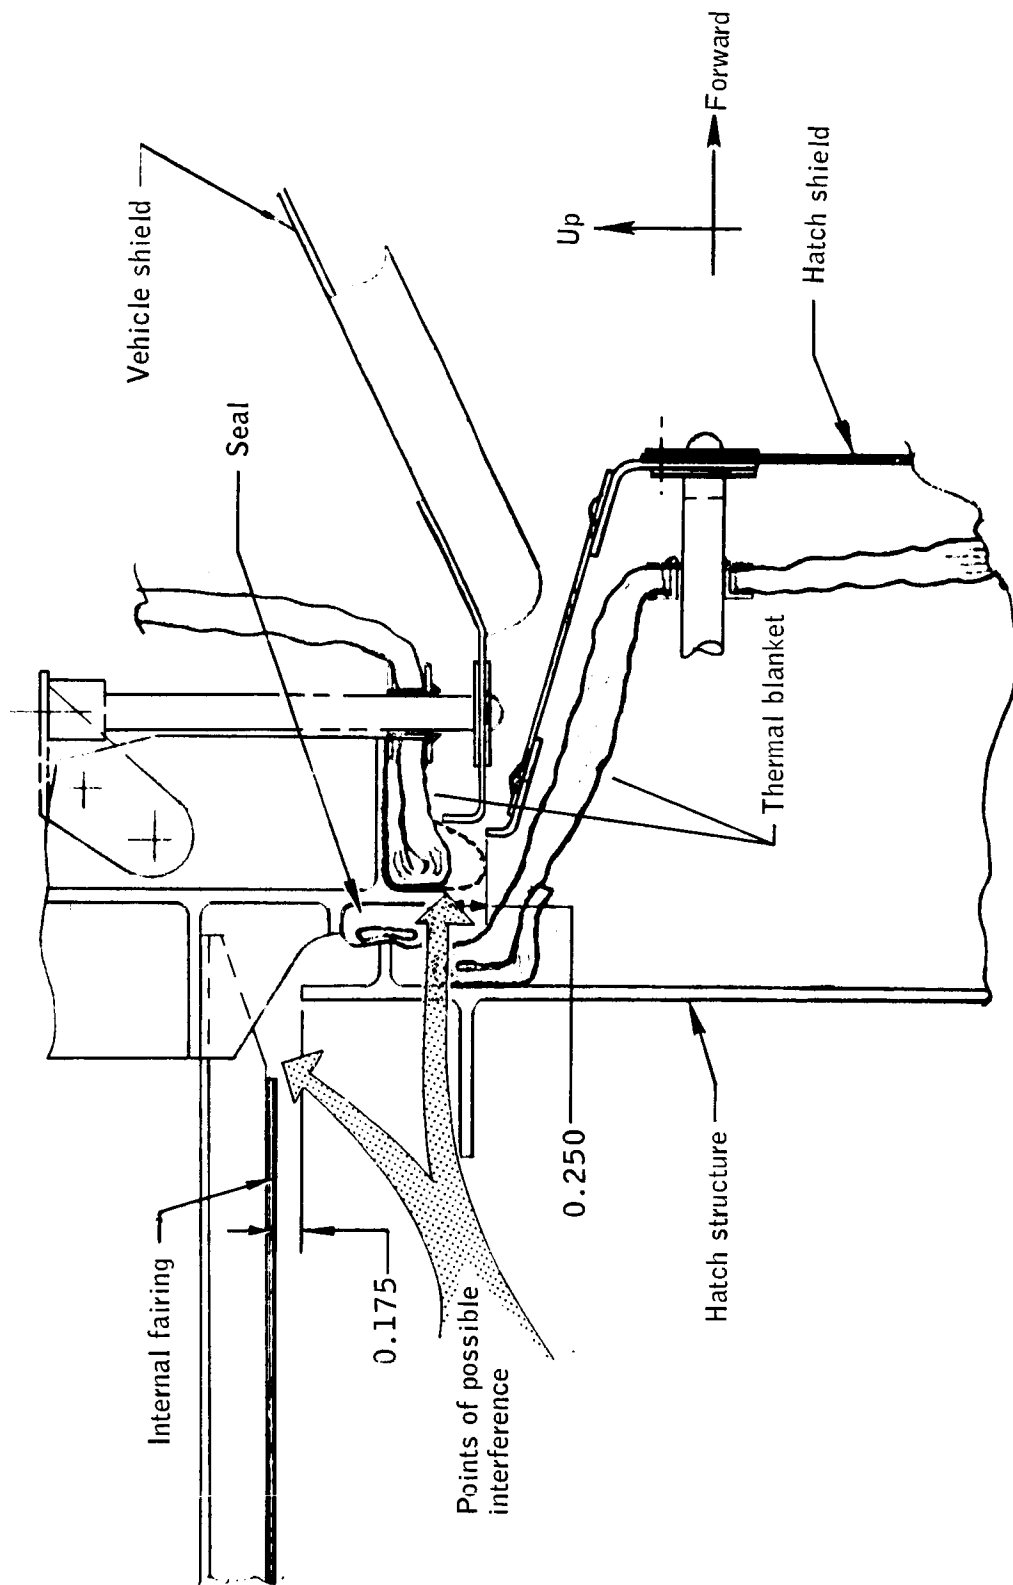
Figure 20.- Potential hatch interferences.

The crew reported that when the forward hatch was opened for extra-vehicular activity, it tended to bind on top and had to be pushed downward to open it. Also, the door would not stay open. Figure 20 shows the potential hatch interference points that could have caused the binding.

Inspection on LM-5 showed that the vehicle front face blanket above and around the hatch opening protrudes below the vehicle fixed structure shielding (in an area where 0.250-inch clearance should exist). This protrusion is in the path of and interferes with the hatch shield lip. LM-4 will be inspected for similar conditions. Corrective action will be to run a strip of tape between the vehicle structure and shield to retain the blanket and prevent it from sagging into the hatch opening.

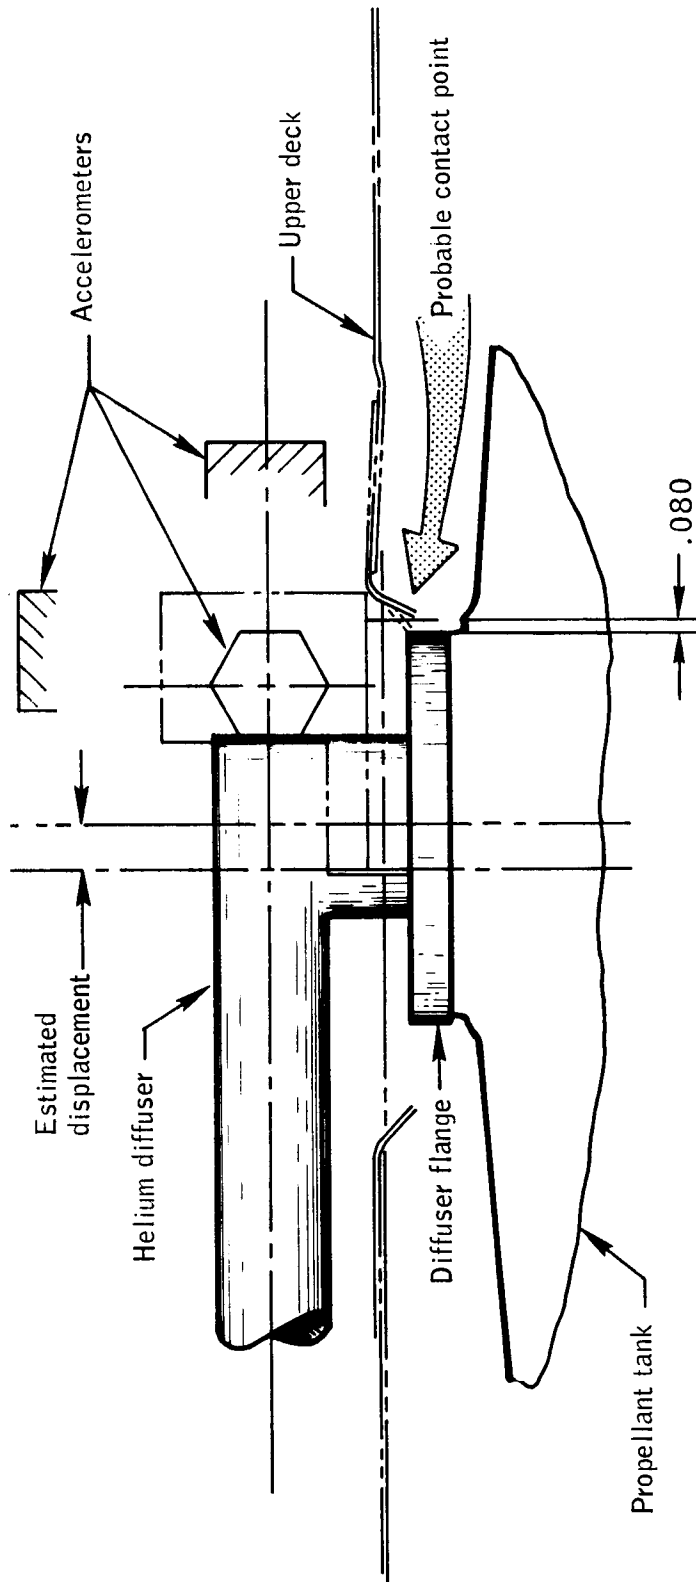
Figure 21.- Probable tank-to-upper-deck contact point.

Data indicate that the lateral loads introduced at S-IC shutdown caused the helium diffuser flange on the descent propellant tank to contact the sheet metal flange of the upper deck (see fig. 21). Analysis has shown that the contact would not damage either the upper deck sheet metal flange or the heavy diffuser flange or tank boss. Analysis also shows that the tank and plumbing are not over-stressed under this condition. The lower weight of LM-4, in conjunction with the S-IC expected shutdown conditions, will produce less deflection for Apollo 10 than was experienced on Apollo 9. Further studies are underway for Apollo 11 weights and shutdown transients.

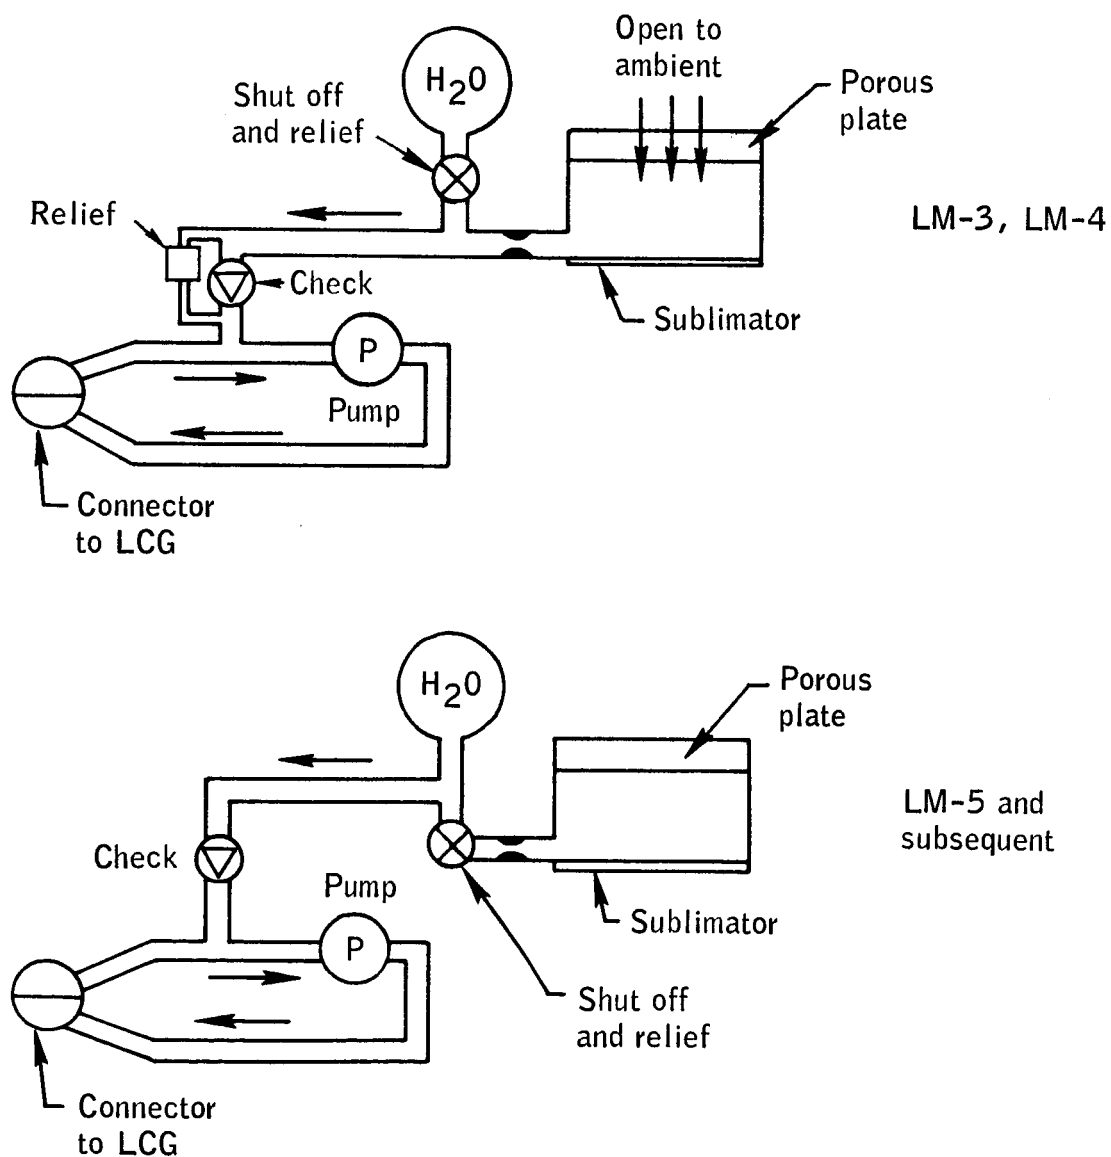
Figure 22.- Air in liquid cooled garment at time of connection to PLSS.

After the Lunar Module Pilot removed his liquid cooled garment on extravehicular activity day, he noted many air bubbles entrained in the liquid tubes.
